# ARCHITECTURAL SURVEY

NEAR WEST HISTORIC DISTRICT  
ST. CHARLES, ILLINOIS

ST. CHARLES HISTORIC PRESERVATION COMMISSION

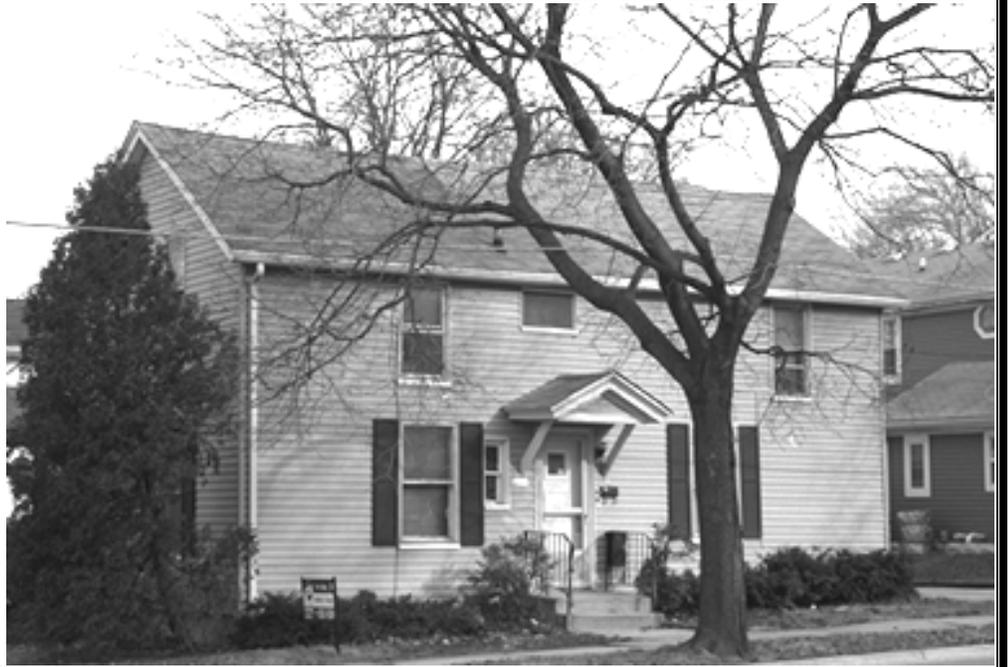
ADDRESS 302 South 3<sup>rd</sup> Street

Architectural Style/Type: National

Date of Construction: 1930

Overall Plan Configuration: Simple rectangle

Exterior Walls (Current): Aluminum

Exterior Walls (Original): Clapboard

Foundation: Concrete

Roof Type/Material: Side gable/Asphalt shingle

Window Material/Type: Aluminum/DbI Hung

**ALTERATIONS:** Little remains of the original materials of the exterior. This house has been aluminized top to bottom. The canopies that cantilever over the front and side entries were added. A gabled wall dormer appears to have been added at the rear of the house. A 1 story addition featuring a shed roof was also added to the rear of the house.

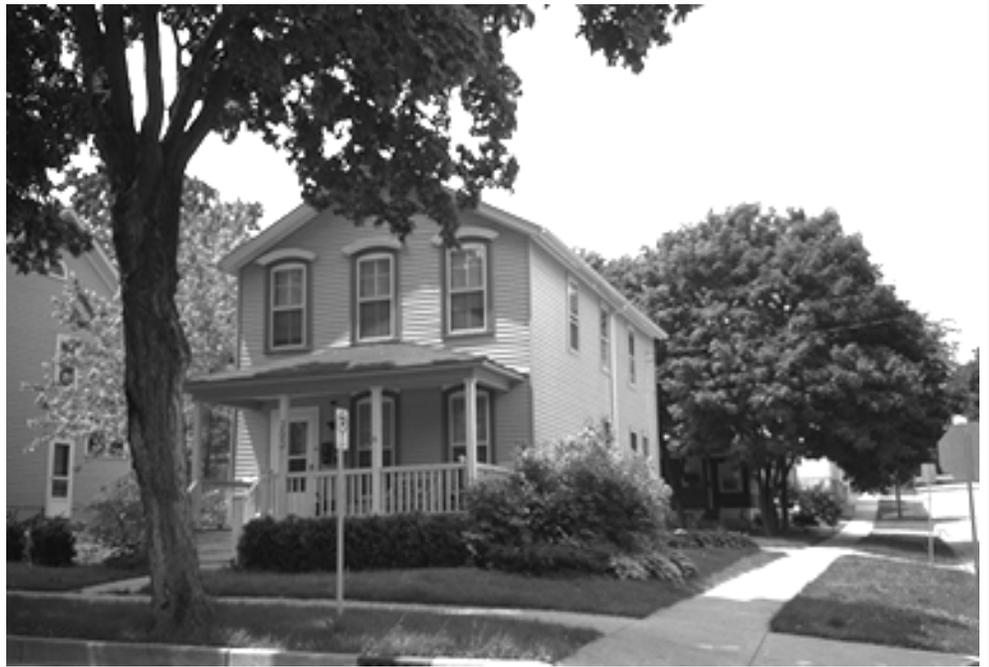
ADDRESS 303 South 3<sup>rd</sup> Street

Architectural Style/Type: National w/ embellishments.

Date of Construction: 1900

Exterior Walls (Current): Aluminum

Exterior Walls (Original): Clapboard

Foundation: Concrete

Roof Type/Material: Front gable/Asphalt shingle

Window Material/Type: Wd trim/Alum Replacement/Dbl hung

**ARCHITECTURAL FEATURES:** The full width front porch and the arched wood trim of the windows located on the front elevation are the most prominent features. The windows are relatively tall in comparison with the façade and add a sense of height.

**ALTERATIONS:** Aluminum soffits, windows, siding, front door have replaced original materials. There is a wooden stair that provides 2F access that was added to the rear of the house. The porch detailing does not appear to be original.

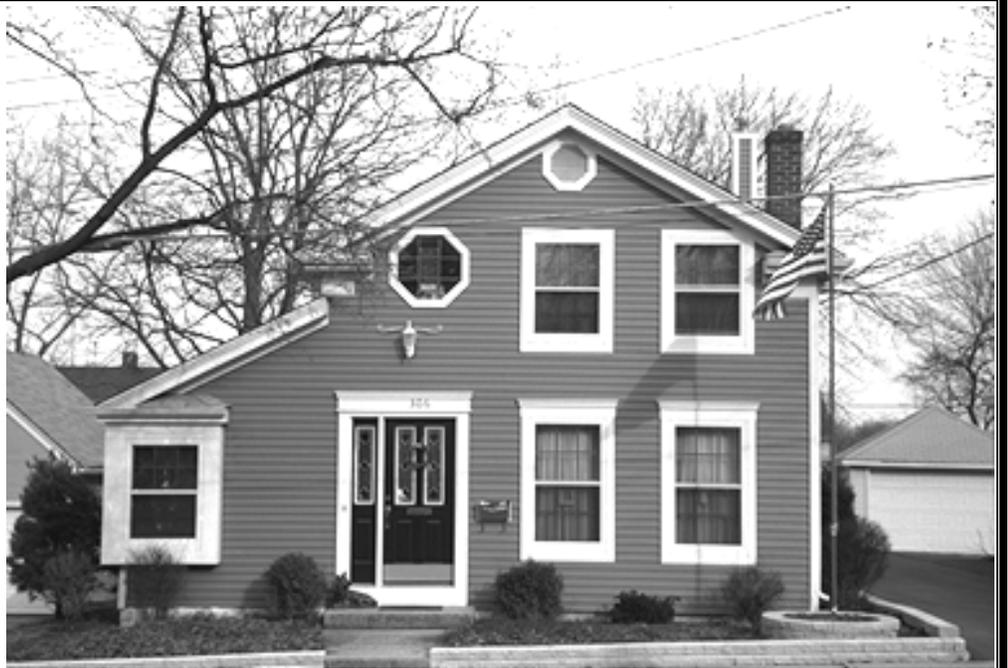
ADDRESS 306 South 3<sup>rd</sup> Street

Architectural Style/Type: Greek Revival – orig.

Exterior Walls (Current): Aluminum

Foundation: Parged stone/Conc. @ adds

Roof Type/Material: Front gable/Asphalt shingle

Window Material/Type: Alum/DbL hung

**ARCHITECTURAL FEATURES:** The street façade has a charming diminutive scale featuring quirky proportions and details.

**ALTERATIONS:** There have been two additions made to this house that can be seen from the street. A 1 - story addition to the north side of the house features a shed roof and a quirky corner window. The large addition to the rear of the house features a gabled roof on axis with the original roof, but higher. The additions are not particularly sympathetic with the original revival style, but are interesting nevertheless. The front elevation has two octagonal openings – one over the front door and one at the peak of the front gable.

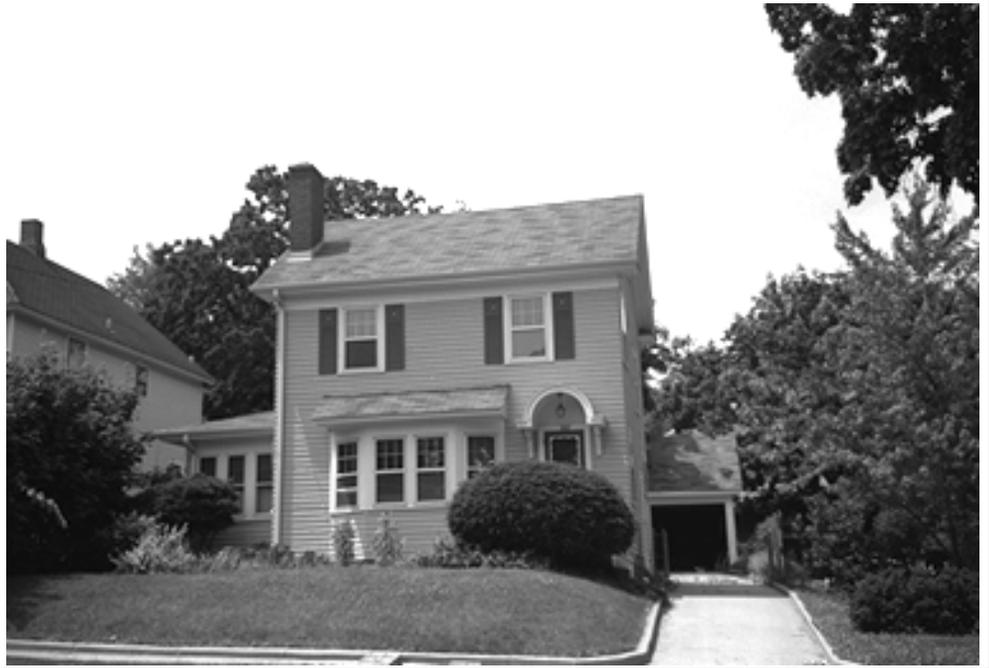
ADDRESS 307 South 3<sup>rd</sup> Street

Architectural Style/Type: Colonial Revival

Overall Plan Configuration: Simple rectangle w/ adds.

Exterior Walls (Current): Clapboard

Foundation: Concrete

Roof Type/Material: Side gable/Asphalt shingle

Window Material/Type: Wd/Alum/Dbf Hung

**ARCHITECTURAL FEATURES:** This is a simply detailed revival style that is not particularly well organized on the front elevation. The openings on the ground floor and the second floor do not align. The shed-roofed bay window looks out of place on the façade. Wooden brackets support the arched canopy over the front door. Lunette windows are placed in both of the gable ends.

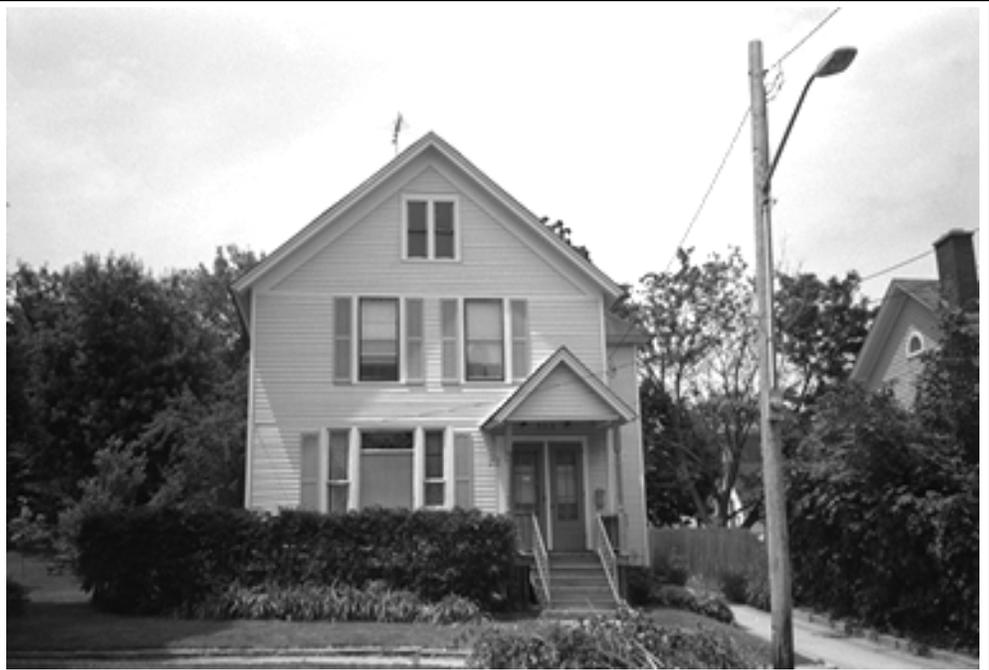
ADDRESS 309 South 3<sup>rd</sup> Street

Architectural Style/Type: Victorian – orig.

Exterior Walls (Current): Alum over the original the Clapboard

Foundation: Stone

Roof Type/Material: Front gable/Asphalt shingle

Window Material/Type: Alum storms over original wood double hung

**ARCHITECTURAL FEATURES:** The original horizontal courses are still evident where siding materials or colors would have changed. These are located at the window heads of the 1<sup>st</sup> and 2<sup>nd</sup> floors. There is a nice stained glass transom over the front room window. Turned columns support the small gabled roof entry porch. The original narrow wooden double doors are still in place at the front entrance.

**ALTERATIONS:** Aluminum siding, soffits, and windows have replaced the original wood features. The original balustrade has been replaced. There have been additions made to the rear of the house that are not seen from the front. A large 2 story addition with a gabled roof paralleling the original was made a little narrower than the original in plan. The smaller width caused an awkward transition at the roof. A smaller shed roofed 1 story addition was also made to the rear of the house.

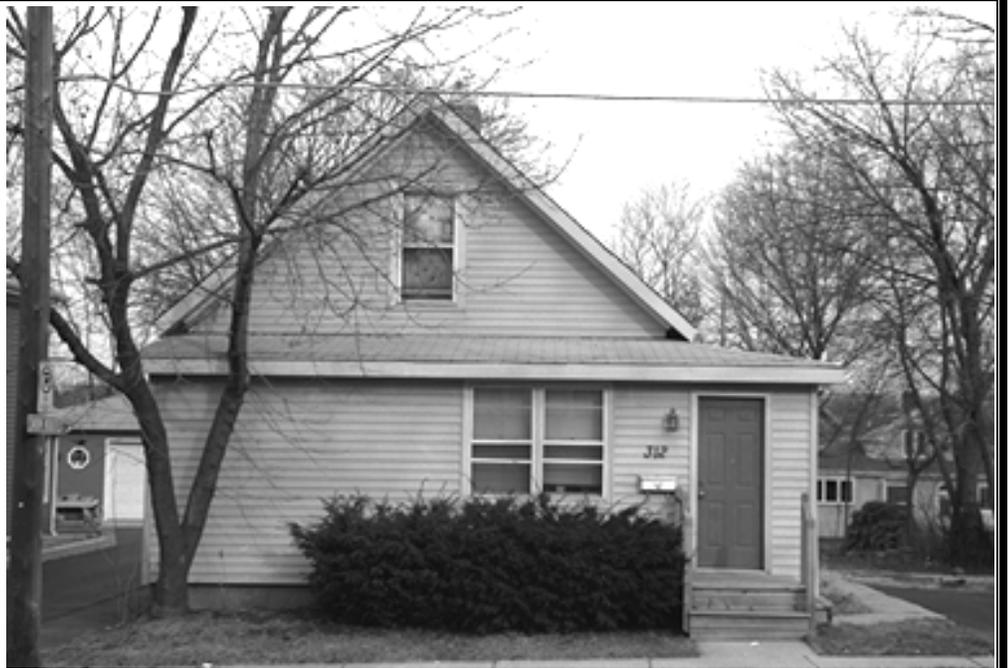
ADDRESS 312 South 3<sup>rd</sup> Street

Architectural Style/Type: National - orig

Exterior Walls (Current): Aluminum

Foundation: Concrete

Roof Type/Material: Front gable/Asphalt shingle

Window Material/Type: Alum/Dbf hung

**ARCHITECTURAL FEATURES:** The original house was probably very plainly detailed in keeping with the style, however all of the original features are concealed.

**ALTERATIONS:** A 1-story addition has been made to the front and south side of the house that has completely concealed all of the original 1<sup>st</sup> floor features. Another 1-story addition was made to the rear of the house that has a gabled roof and a small porch. Aluminum siding, windows, and soffits obfuscate almost all of the original house surfaces.

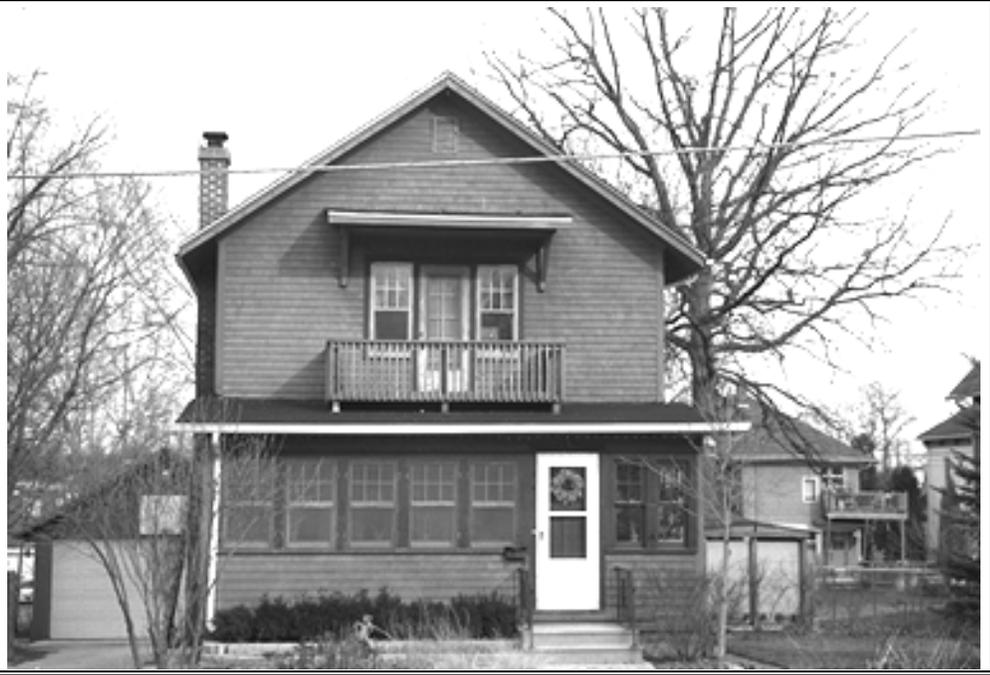
ADDRESS 318 South 3<sup>rd</sup> Street

Architectural Style/Type: Folk Victorian

Exterior Walls (Current): Wood shingles

Foundation: Textured CMU

Roof Type/Material: Front gable/Asphalt shingle

Window Material/Type: Wood/Dbh hung

**ARCHITECTURAL FEATURES:** The wood shingled siding is the most prominent feature of the house aside from the color. The elevations are sparingly detailed. There is a brick chimney located on the north side of the house.

**ALTERATIONS:** The front porch has been closed in to make a 3 or 4 season room. The 2F triple window has been altered to receive a single door in the middle module that provides access to an added balcony. The balcony railing is plain and unrelated to the original design. Ornamental wooden brackets support the shed roof canopy added over the door to the balcony. A small 1-story addition with a shed roof was made to the rear. It is relatively sympathetic to the original house.

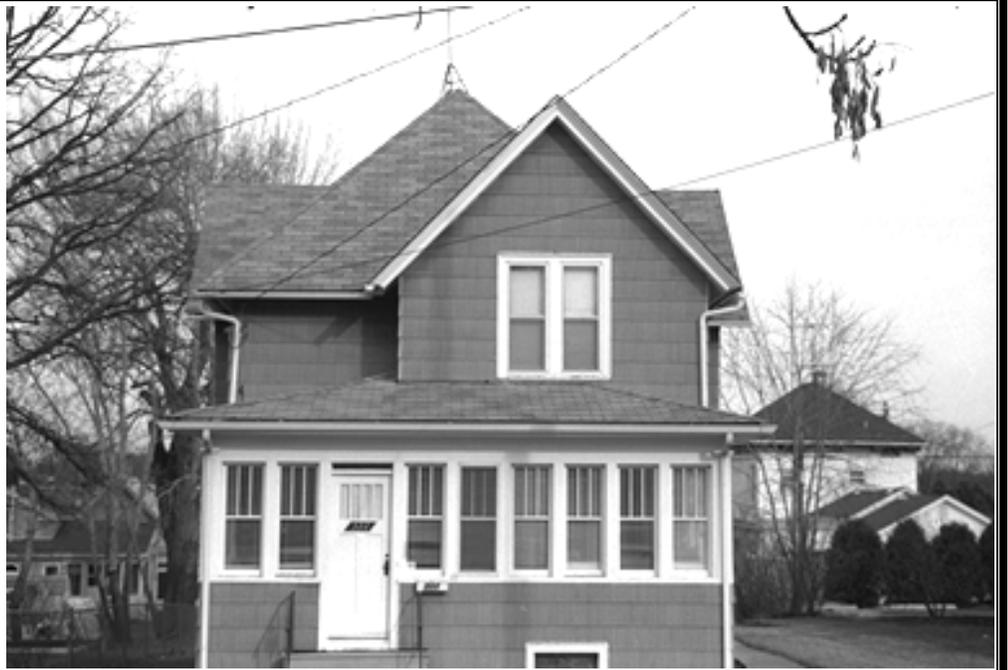
ADDRESS 322 South 3<sup>rd</sup> Street

Architectural Style/Type: Victorian/Queen Anne

Exterior Walls (Current): Asphalt shingle

Foundation: Parged masonry

**ARCHITECTURAL FEATURES:** There is a nice spindle work porch at the rear of the house – the last vestige of the detailing that was probably typical around the house. There is one stained glass window on the north elevation. The side gable on the south elevation has cutaway corners without any significant detailing. The roof massing and the scale are indicative of the style...little else remains.

**ALTERATIONS:** The entire house has been altered in some fashion. The siding has been noted, as have the windows. The porch was closed in to make the 3-season room. The original masonry foundation has been parged and then detailed with a stain or paint to simulate stone coursing

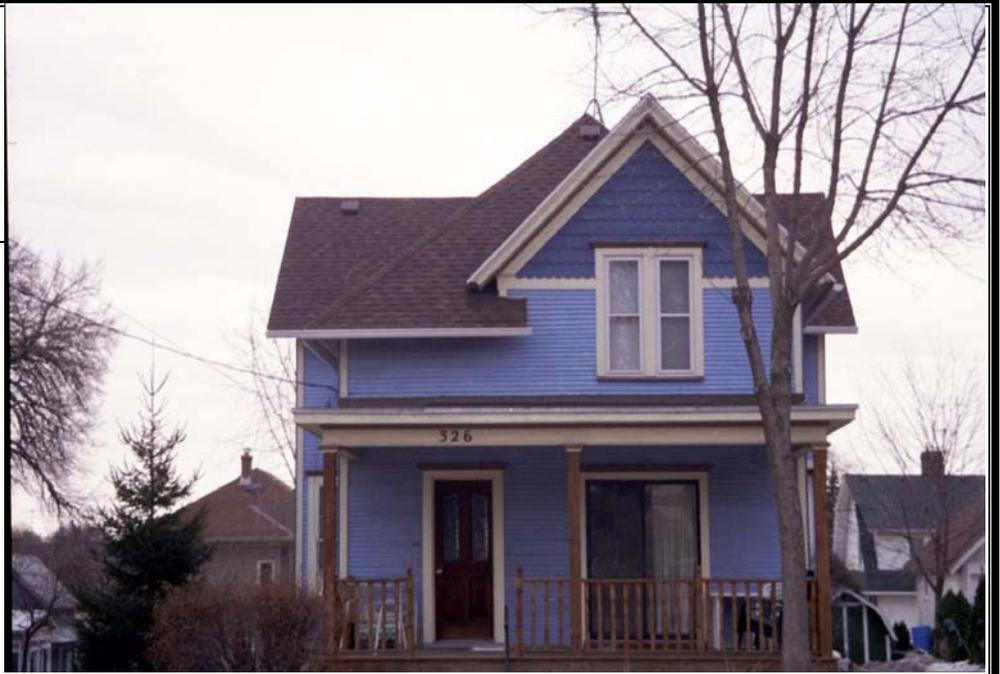
ROLL-IMAGE # 2727 - 16

Foundation: Stone veneer over original

**ARCHITECTURAL FEATURES:** There is a lot of nice wood trim and details around the house. The front and side gables feature fish scale shingles. The window heads are trimmed with a crown molding. The stair window to the north side of the house is glazed with the original stained glass. The side gables feature cut out corners at the first floor without the pendant wood trim sometimes seen in similar examples of the style.

**ALTERATIONS:** The front porch has been remodeled. The original columns, probably turned, have been replaced with plain square columns. The balusters are turned. A sliding glass door replaced the original front room window. There is a 1½-story addition at the rear of the house that features a gabled roof. It is sympathetic with the original design. A 2 level wooden deck was added to the east side of the first addition. It is not compatible with the original house.

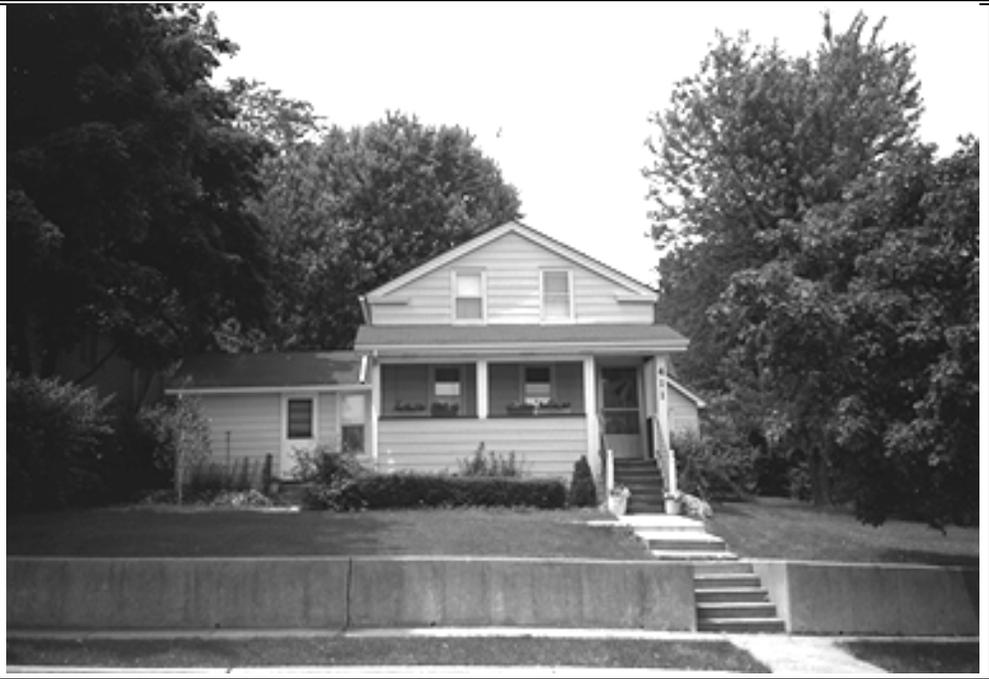
ROLL-IMAGE # 70552 - 5

Foundation: Parged masonry/Concrete

**ARCHITECTURAL FEATURES:** The 1 ½-story façade of the original house and the shallow roof slope causes this house to have a storybook scale. The discontinuous trim at the front gable and the shallow roof slope indicate that this could have been a Greek Revival cottage at one time. It is difficult to say with certainty since the original detail features have been obscured with remodeling “improvements.”

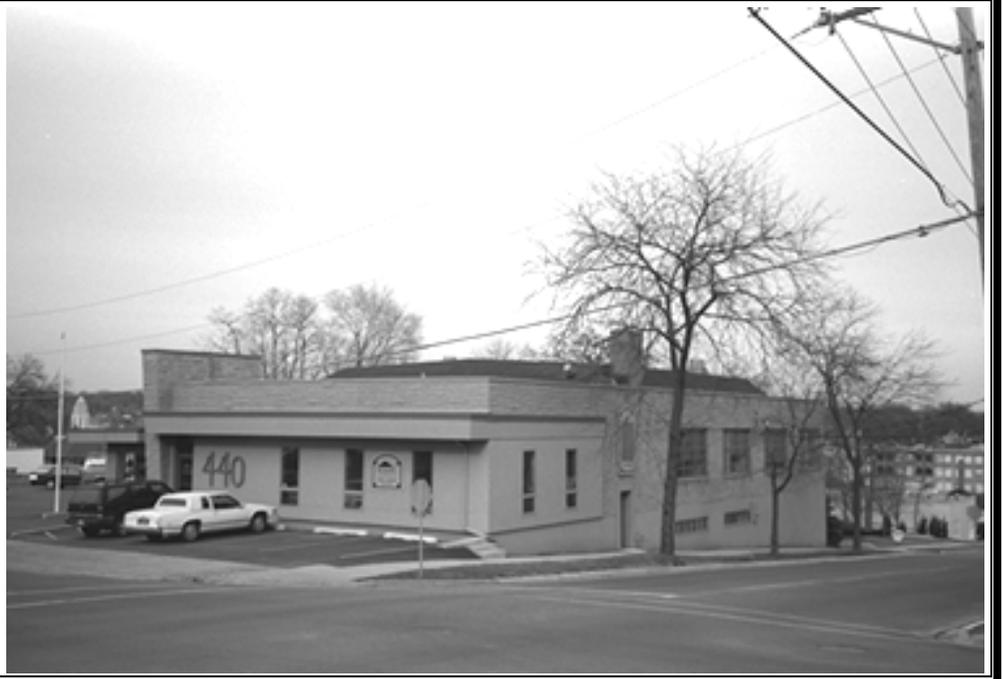
ROLL-IMAGE # 101 - 4

Foundation: Concrete

**ALTERATIONS:** The EIFS at the front and the rear of the building is a significant alteration of the original. Aluminum windows replaced the original steel windows in some areas. New windows were cut into the concrete foundation on the south elevation.

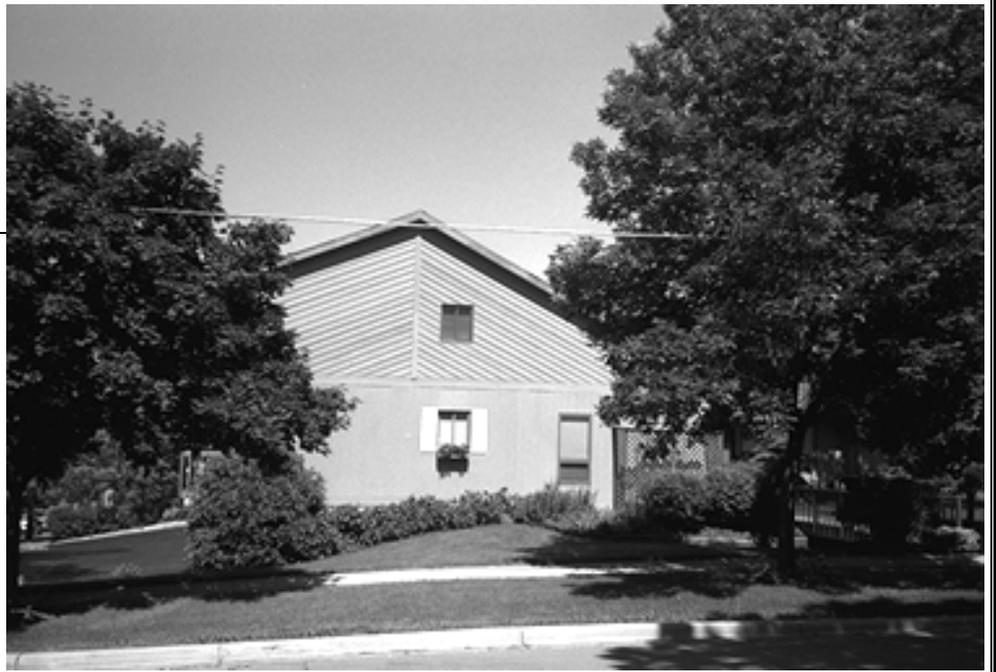
ROLL-IMAGE # 70551 - 21

Architectural Style/Type: <u>Contemporary multifamily</u>	Exterior Walls (Current): <u>Wood</u>
Architectural Features: _____	Exterior Walls (Original): <u>Wood</u>
Date of Construction: <u>1987</u>	Foundation: <u>Concrete</u>
Source: <u>Township Assessor's Office</u>	Roof Type/Material: <u>U-shaped gable</u>
Overall Plan Configuration: <u>Simple U-shape</u>	Window Material/Type: <u>Aluminum/awning/sliders</u>

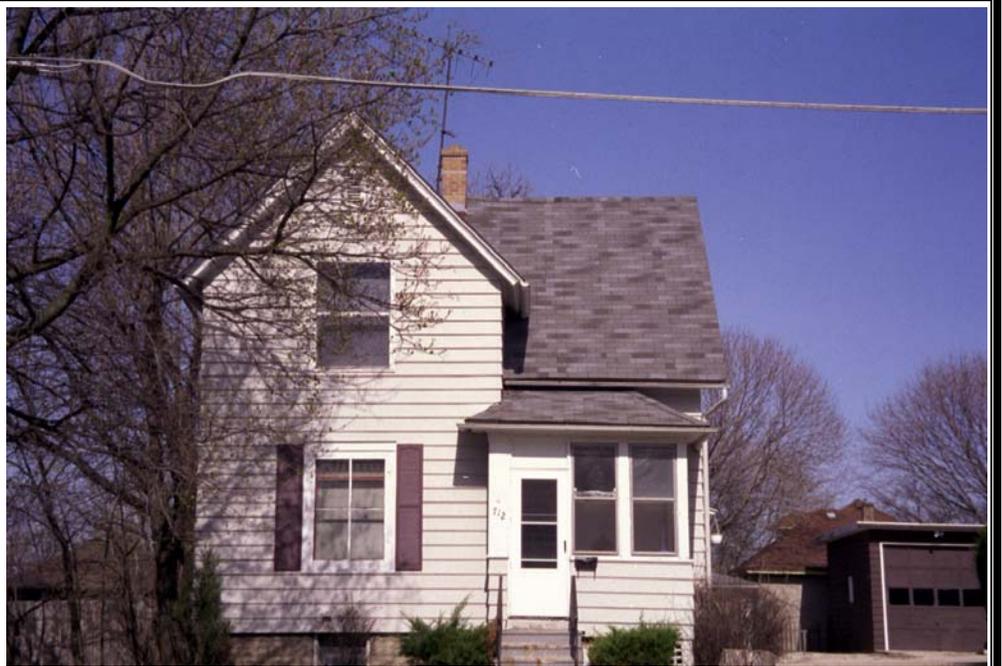
ROLL-IMAGE # 0013 - 5

Foundation: Textured CMU

**ALTERATIONS:** Aluminum siding, windows, doors have been installed in place of the original materials. The small front porch has been screened in changing the scale of the front elevation. A 1-story addition has been made to the rear. This addition has a flat roof with rolled roofing material. The massing, shape, and the roof are not compatible with the original style. The rear foundation appears to be damaged through settling.

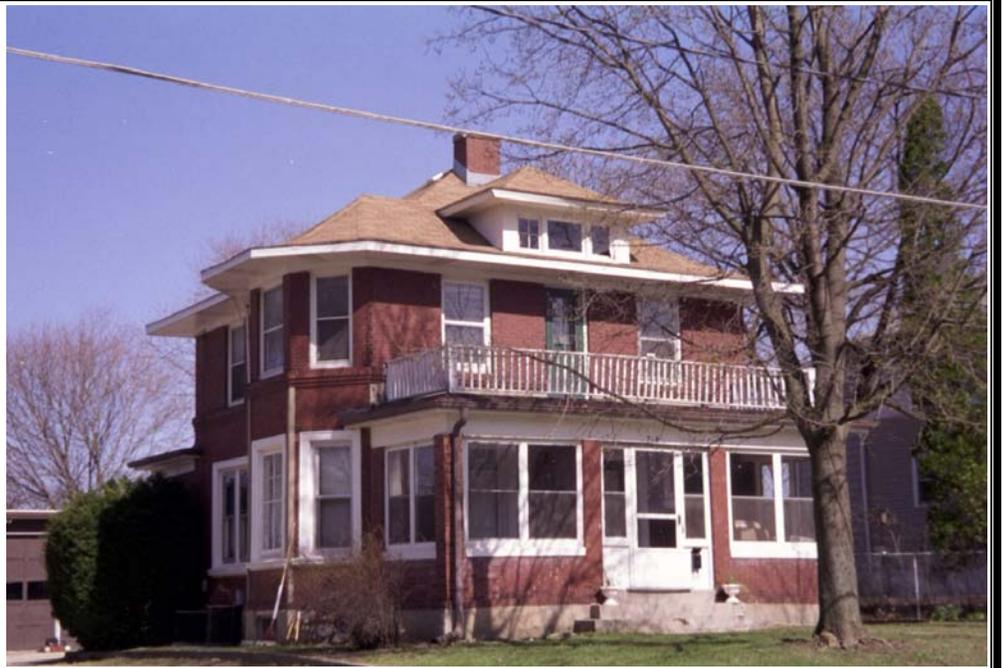
ROLL-IMAGE # 0013 - 6

Architectural Style/Type: <u>Eclectic 4square</u>	Exterior Walls (Current): <u>Brick</u>
Architectural Features: _____	Exterior Walls (Original): <u>Brick</u>
Date of Construction: <u>1920</u>	Foundation: <u>Parged masonry</u>
Source: <u>Township Assessor's Office</u>	Roof Type/Material: <u>Hipped/Asphalt shingle</u>
Overall Plan Configuration: <u>4 square</u>	Window Material/Type: <u>Wd trim/Alum Dbl hung</u>

**ARCHITECTURAL FEATURES:** The roof is flared at the front right to match the flare that ties the 2 story corner bay to the main part of the roof. There is a brick corbel placed at the sill of the second floor windows. The wood trim surrounding the first floor windows is typically wide and features a classic molding profile. The second floor windows do not share this trim detail. There is stained glass in the transom of the front window concealed by the screened in front porch. The wide eaves are boxed in with aluminum. There is a brick chimney located at the peak of the hipped roof.

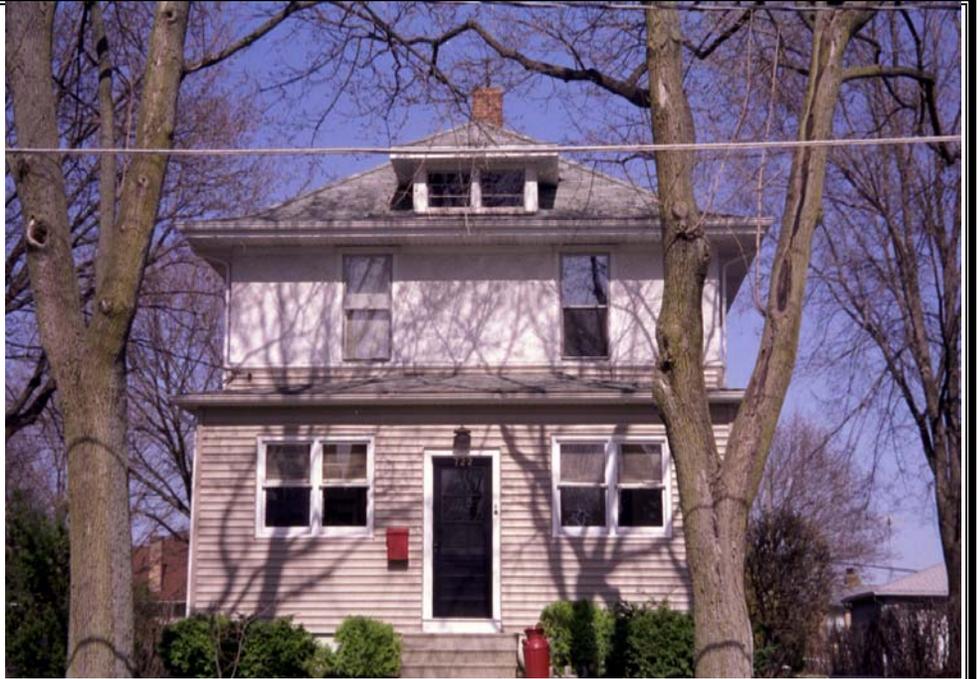
ROLL-IMAGE # 0013 - 7

Architectural Style/Type: <u>Prairie 4 square</u>	Exterior Walls (Current): <u>Stucco/Asphalt shingles</u>
Architectural Features: _____	Exterior Walls (Original): <u>Clapboard</u>
Date of Construction: <u>1925</u>	Foundation: <u>Parged masonry</u>
Source: <u>Township Assessor's Office</u>	Roof Type/Material: <u>Hipped/Asphalt</u>
Overall Plan Configuration: <u>4 square</u>	Window Material/Type: <u>Alum/Dbf hung</u>

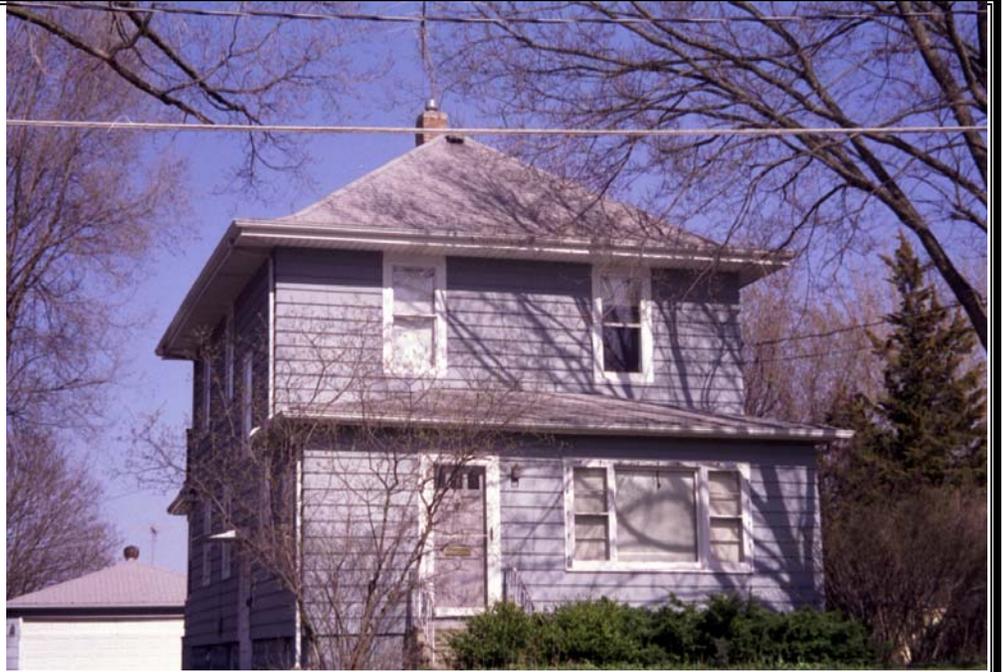
ROLL-IMAGE # 0013 - 8

Foundation: Textured CMU

**ALTERATIONS:** The front porch was closed in to make a year round space. The foundation of the porch was done with smooth CMU, not with the original textured CMU. Aluminum siding replaced the original clapboard siding. It appears that this house was built at the same time as the houses located @ 715 South 3<sup>rd</sup> and 722 South 3<sup>rd</sup> Street and that the remodeler wanted to look different from the neighbors. The soffits have been boxed in with aluminum and the windows have been remodeled with aluminum replacements. A 1-story addition was made to the rear of the house that has a flat roof with a wood deck and railing.
